EXISTING LEVELS OF SERVICE

PEDESTRIAN CIRCULATION AND FACILITIES

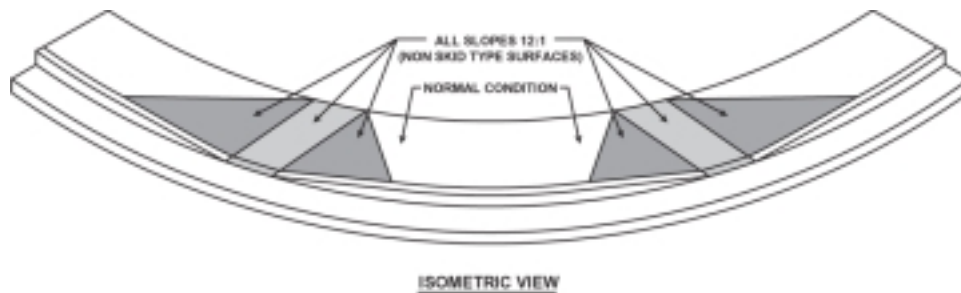
Figure 22
Double Ramp Configuration

In both the District of Columbia and in Maryland, there is evidence of recent widening and upgrading of sidewalks and disabled access ramps, although there are more upgrades noted in the District. There are primarily two different ramp configurations observed in both jurisdictions. The double ramp configuration, shown in Figure 22, provides two perpendicular ramps on a single corner that allows the user to mount a ramp and then turn 90 degrees to wait for the opposing pedestrian signal to change. The single corner ramp configuration, shown in Figure 23, places a single, larger ramp directly at the corner of the intersection. The user can mount the ramp and turn to wait for the signal change without having to maneuver onto a second ramp. Both configurations are utilized in both jurisdictions with single corner ramps being used primarily at the "T" intersections.

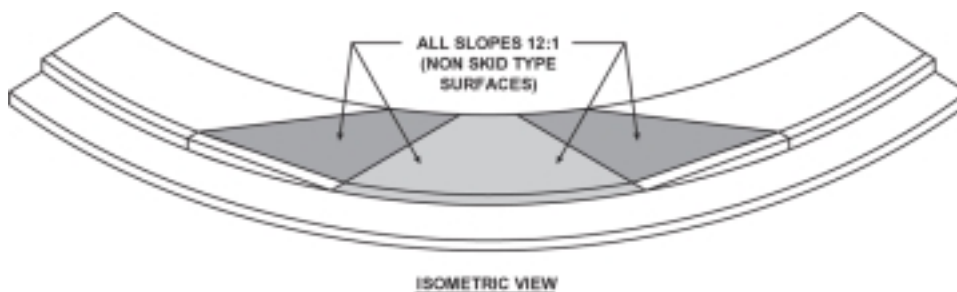
Figure 23
Single Corner Ramp Configuration

Most crosswalks are striped; although there are several locations where the striping does not properly coincide with the ramp locations. This unmatched striping was especially significant with the single corner ramp configuration where improper placement would guide the user into the middle of an intersection in order to access the ramp.
